2014 Flood Event Assessment - Southeast Saskatchewan

PROJECT NO. 2711-15006-0
Saskatchewan Water Security Agency

November 14, 2014

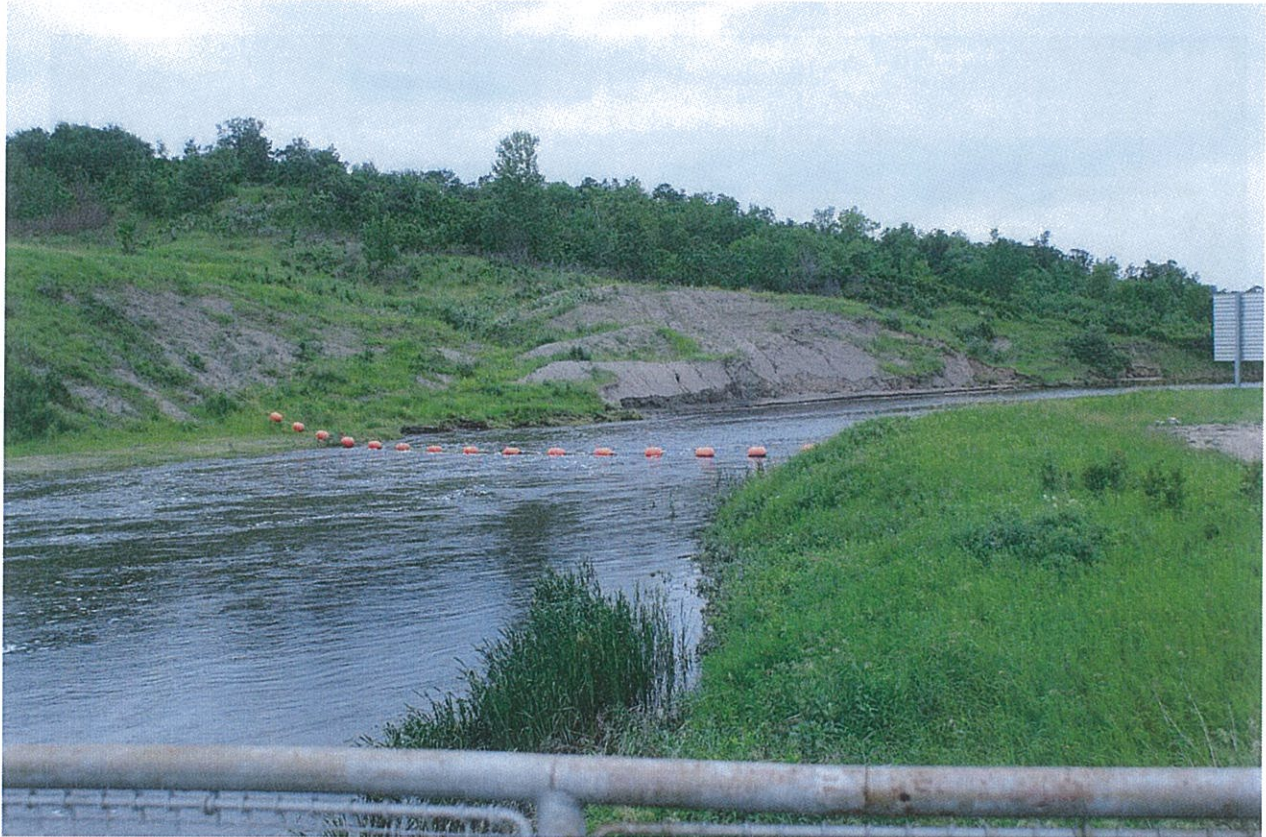
Figure 4: Moosomin Dam – minor side bank erosion near spillway July 6, 2014

Only minor bank erosion was noted by McElhanney on July 6, 2014. The dam was later inspected by AAFC and appears to have not suffered major damages from the flood.

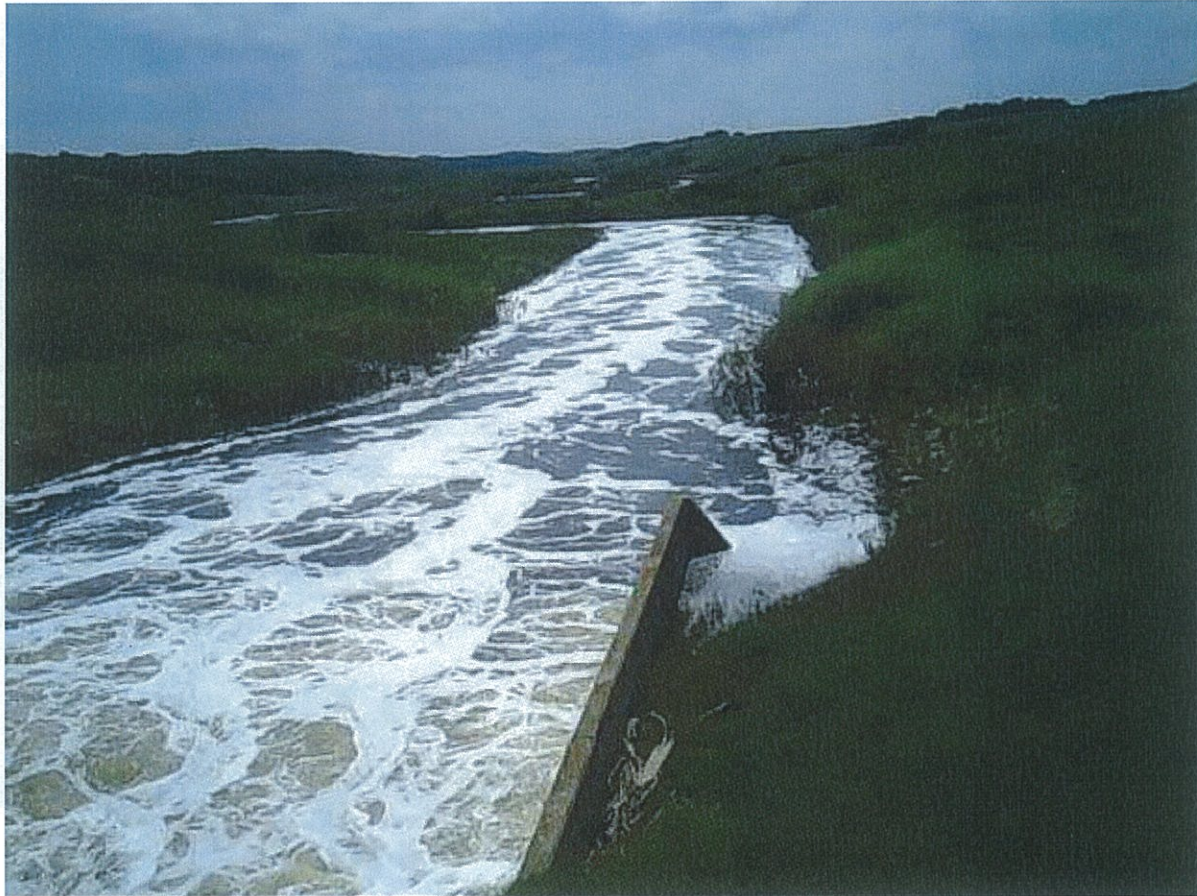
Figure 5: Pheasant Creek Dam – water flowing swiftly down spillway July 10, 2014. No damage noted

AAFC conducted a preliminary inspection of the dam and found that the spillway and embankment appear to be in good shape. A more complete inspection will be carried out at a later date when water levels have receded further; however, no major issues are anticipated.

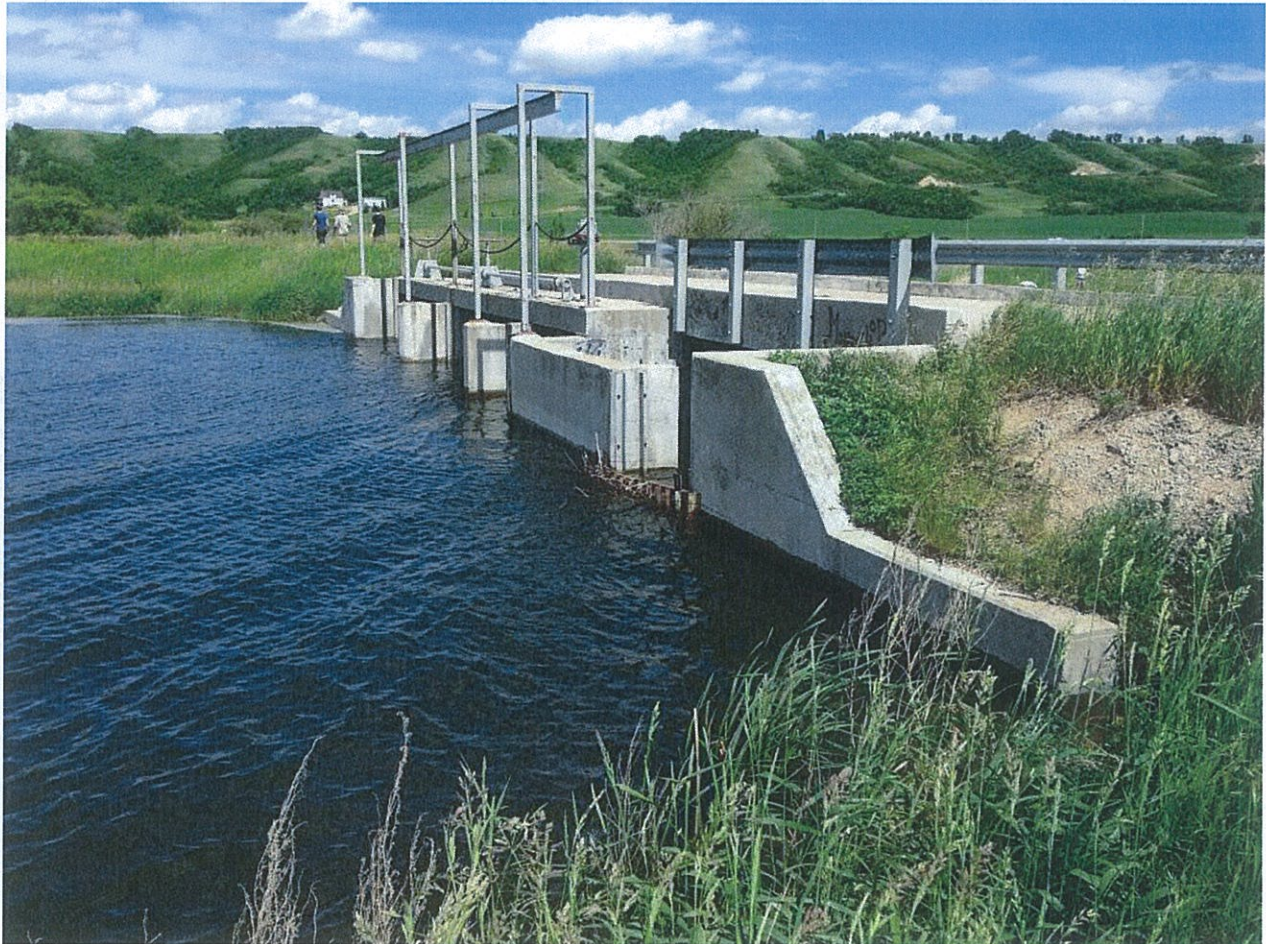
Figure 6: Katepwa Dam – July 6, 2014.

Katepwa Dam is operated by WSA, who has roughly estimated that damages from the June 2014 flooding to the structure to be approximately \$55,000.

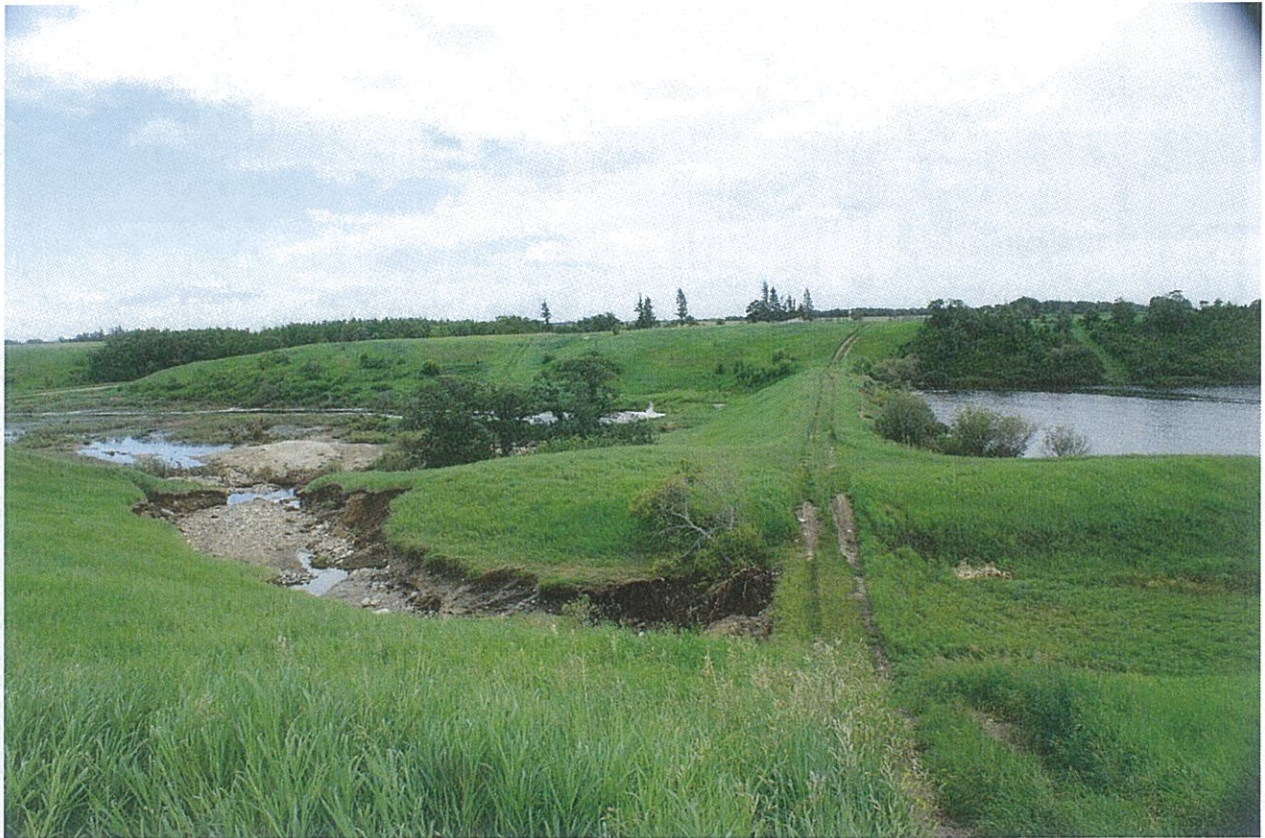
Figure 7: Welwyn Dam – spillway significantly eroded by floodwater

The Welwyn Reservoir is situated in the Beaver Creek Valley in the Welwyn Centennial Regional Park, and is owned and operated by the RM of Rocanville. The flood water did not overtop the Dam; however, the emergency spillway was significantly eroded and will require repair. The RM does not currently have an assessed value of the damages.

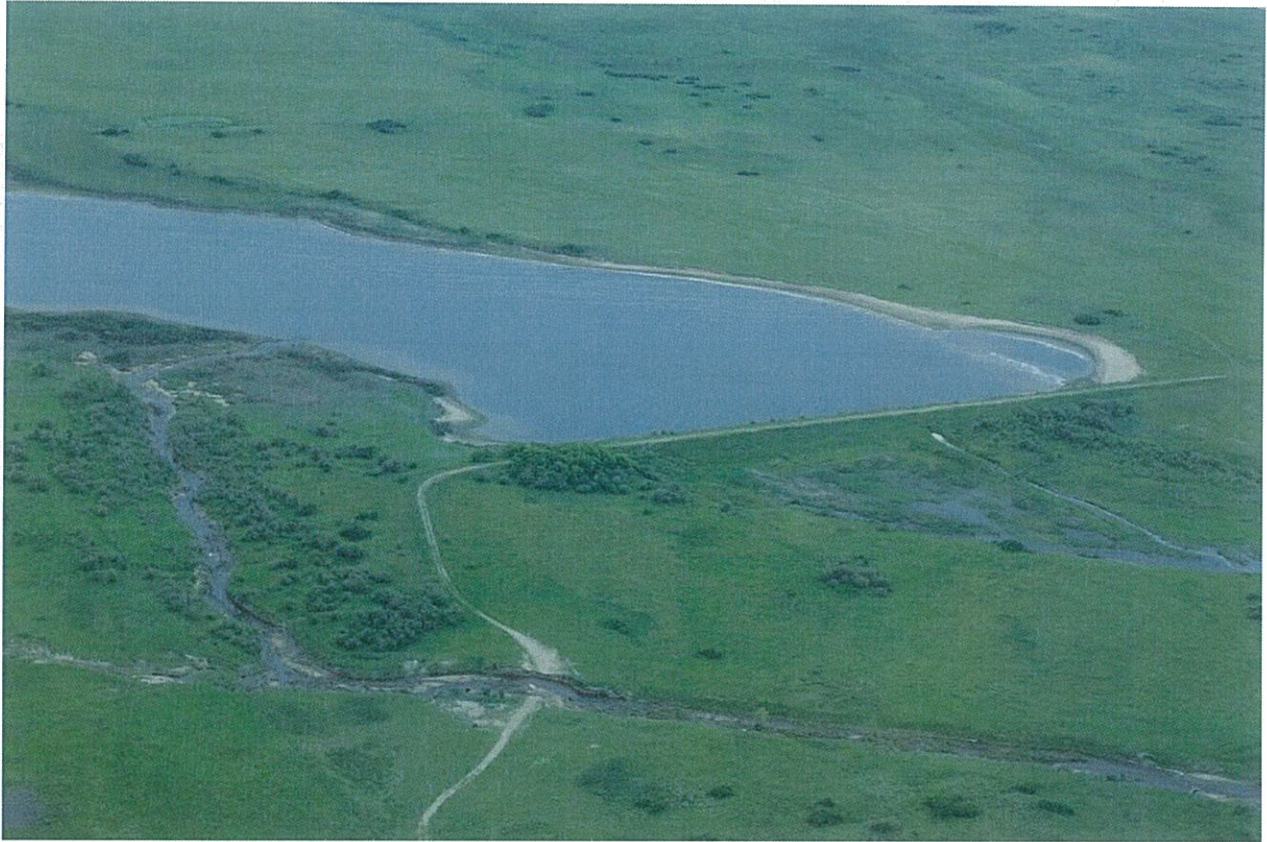
Figure 8: Dam south of Alida, Jul 7, 2014

McElhanney flew past Auburnton Dam on July 7, 2014. It appeared that although the dam was intact, significant erosion had occurred through the old spill channel, as shown in Figure 8.

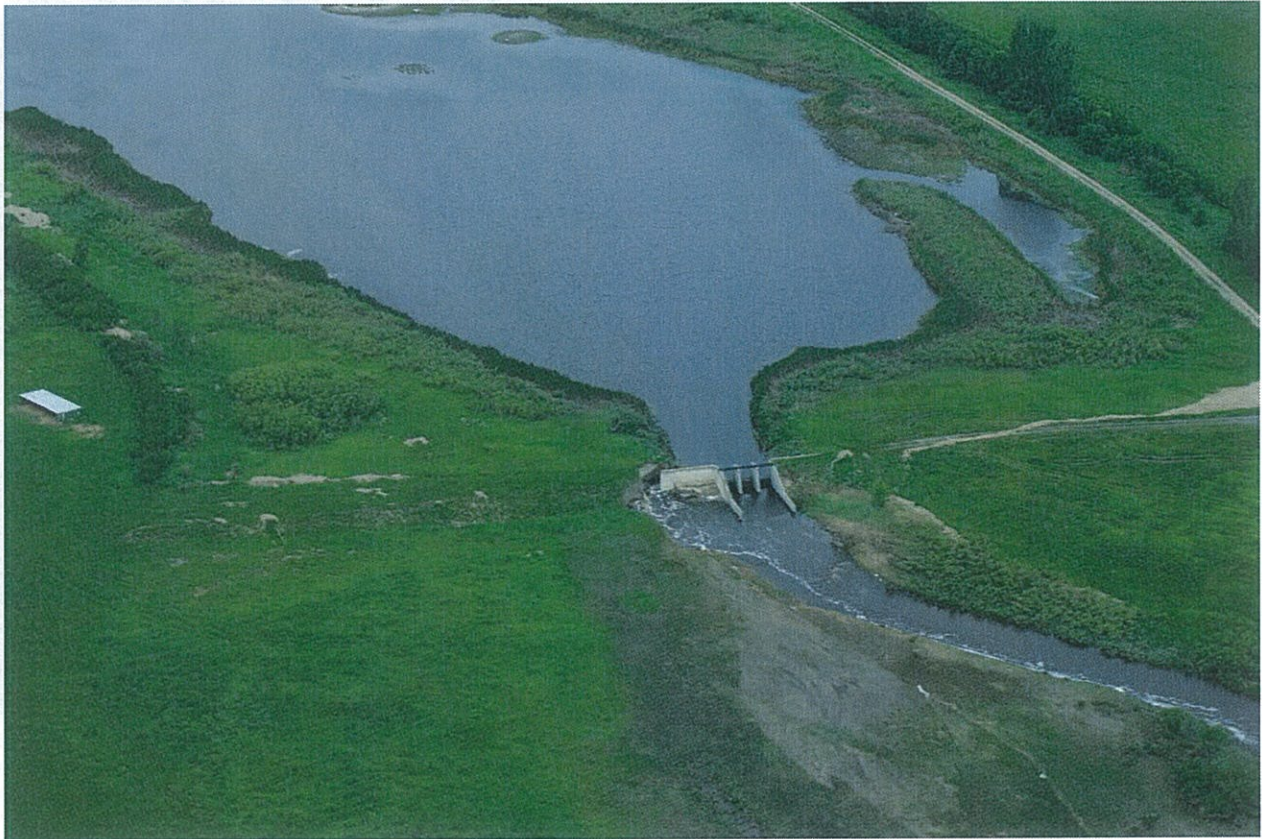
Figure 9: Redvers Dam on July 7, 2014

Redvers Dam is located on Lightning Creek, two kilometres north of Redvers. The control structure is currently licensed and operated by the RM of Antler. McElhanney flew over the Redvers Dam on July 7, 2014, while a ground crew arrived at the dam on July 8, 2014. At that time, flood water was flowing around one abutment, with no water flowing over the dam, however, high water marks (as seen in Figure 10) indicate that water was flowing over the dam before erosion occurred beside the abutment; causing water to flow around the dam. Minor erosion is evident near the other abutment.

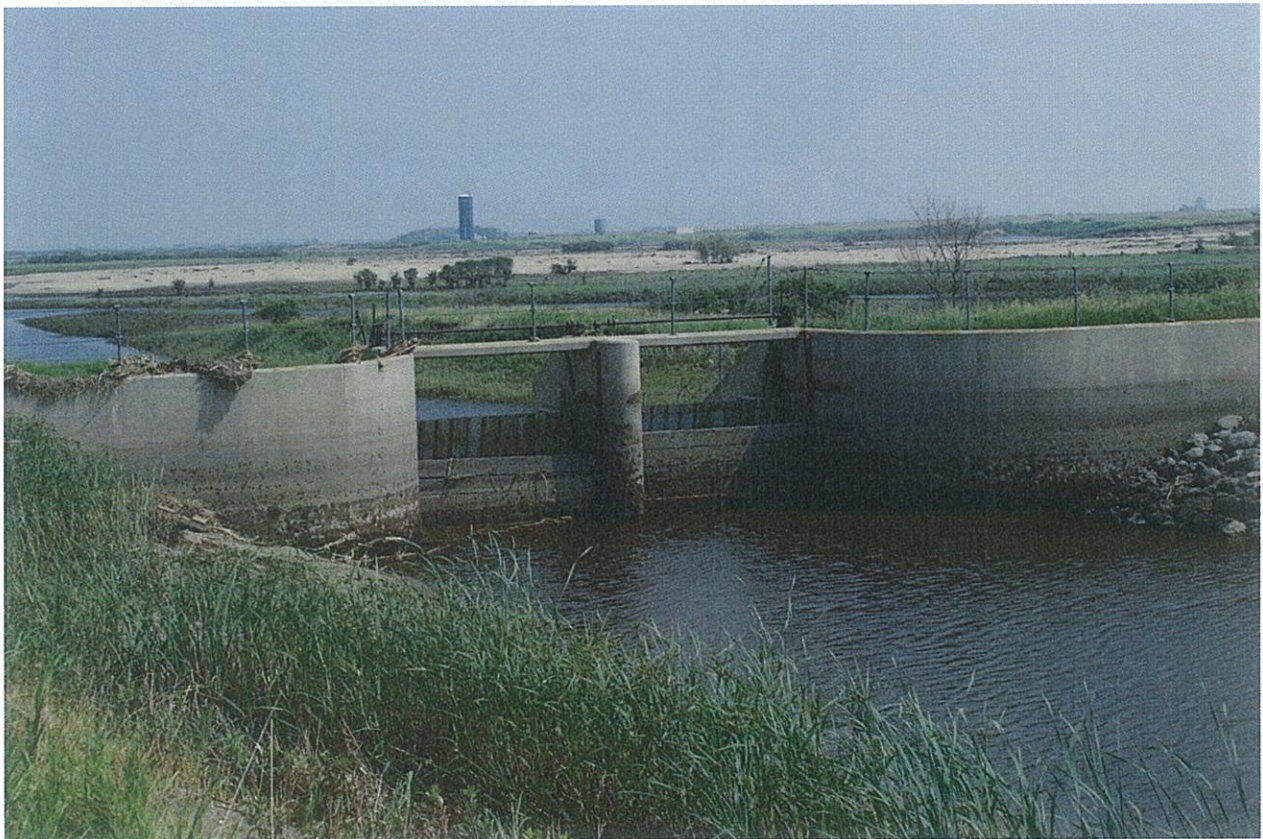
Figure 11: Gainsborough Dam – control structure July 8, 2014.

The Gainsborough Dam is owned and operated by the RM of Argyle, and was visited by McElhanney staff on July 8, 2014. Figure 11 shows stoplog bays partially closed and radial gates partially up. High water marks are marked with grassy debris, and it is evident that floodwater overtopped the control structure, as well as the northern part of the earthen dam structure; however, at the time of the site visit, the water level was below the usual level. The flood water breached the dam and created a new channel south of the dam, as shown in Figure 12 and Figure 13. Erosion of the landscape can be seen in the background in Figure 11 as well as in Figure 14. The RM has noted that they opened the gates during the spring of 2014; however, uncertainty remains at this time of how the dam was operated during the flood event.

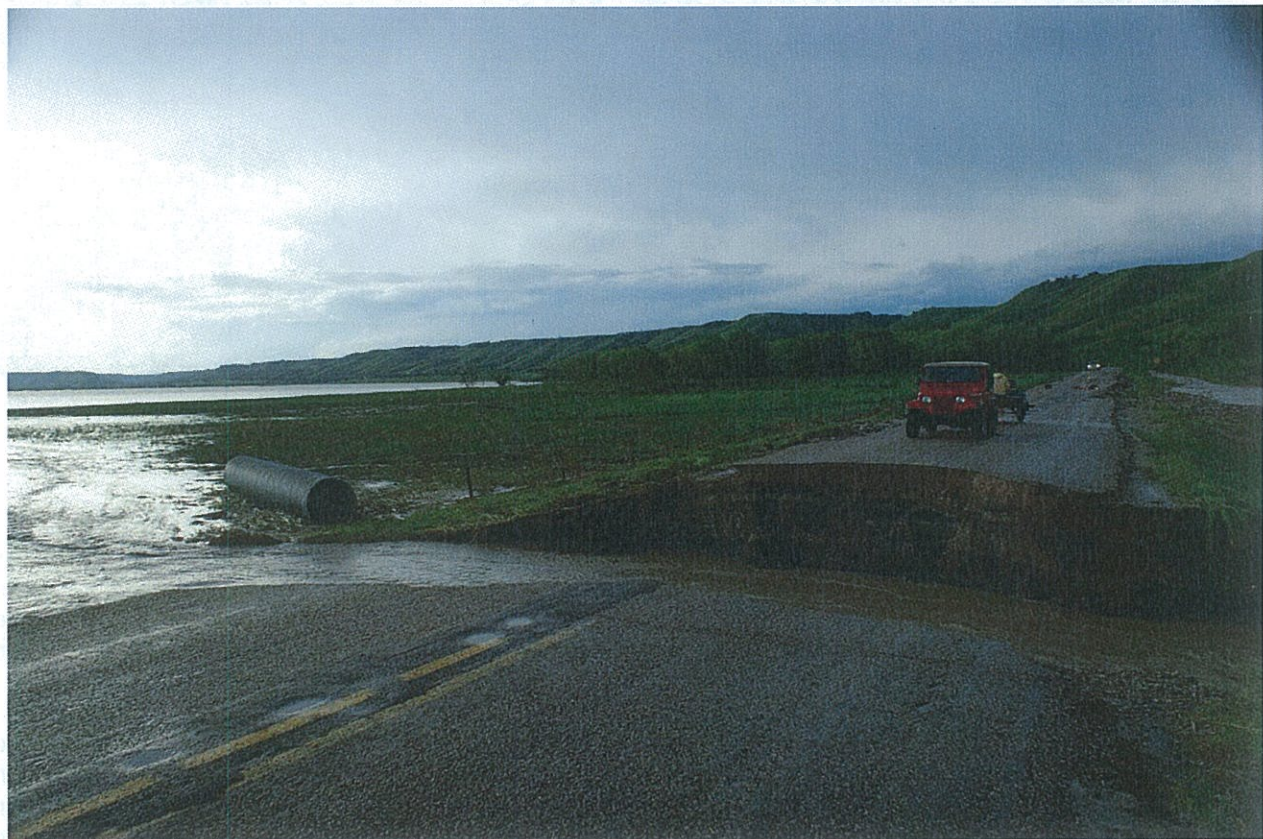
Figure 18: Example of a small-scale washed out road; Qu'Appelle Valley on July 5, 2014

An example of a washed out road can be seen in Figure 18 below, while Figure 19 and Figure 20 show water overflowing the road. It was observed that roads often acted as dykes for the flood waters.

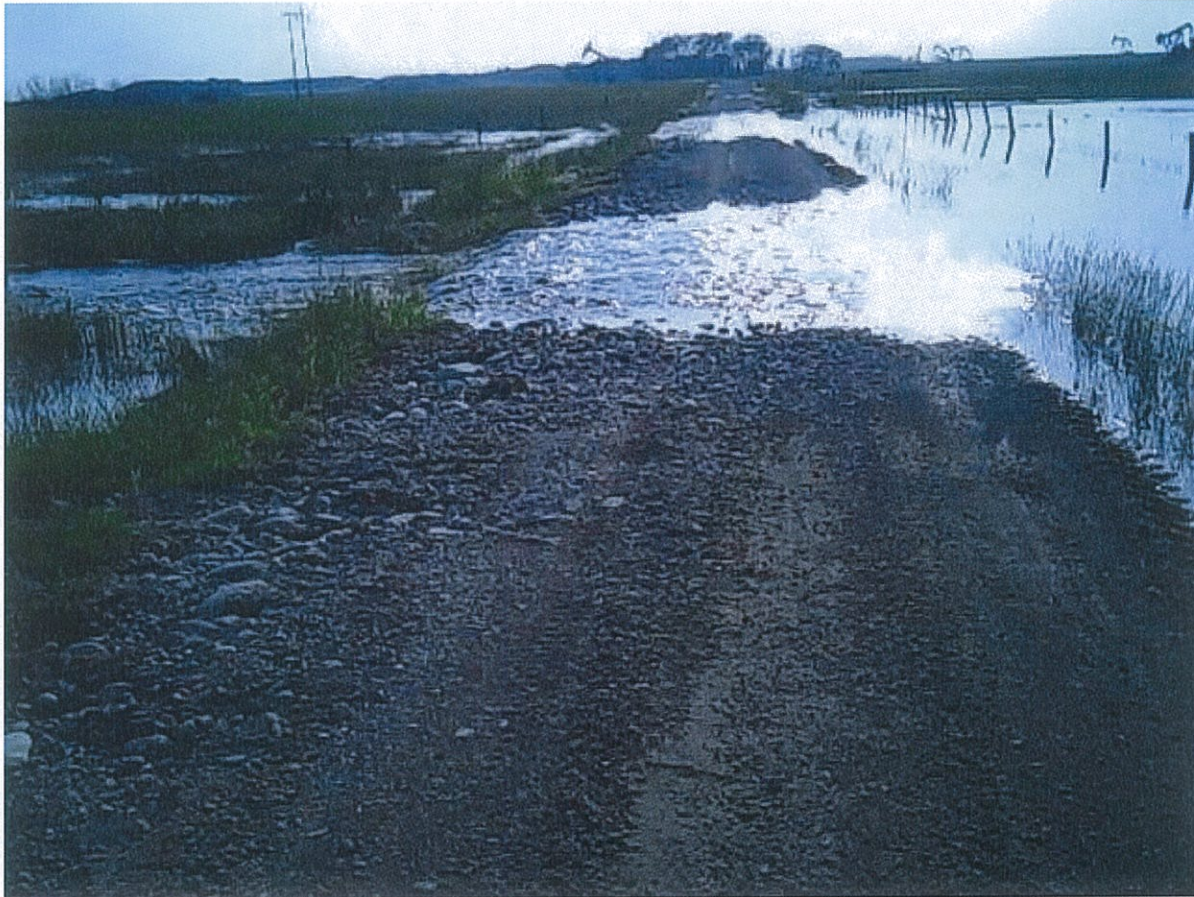
Figure 21: Floodwater flowing across road on either side of the culverts

It appeared that roads and culverts were generally washed out less often when flood water was able to flow across the road on one or both sides of the culverts, as shown in Figure 21.

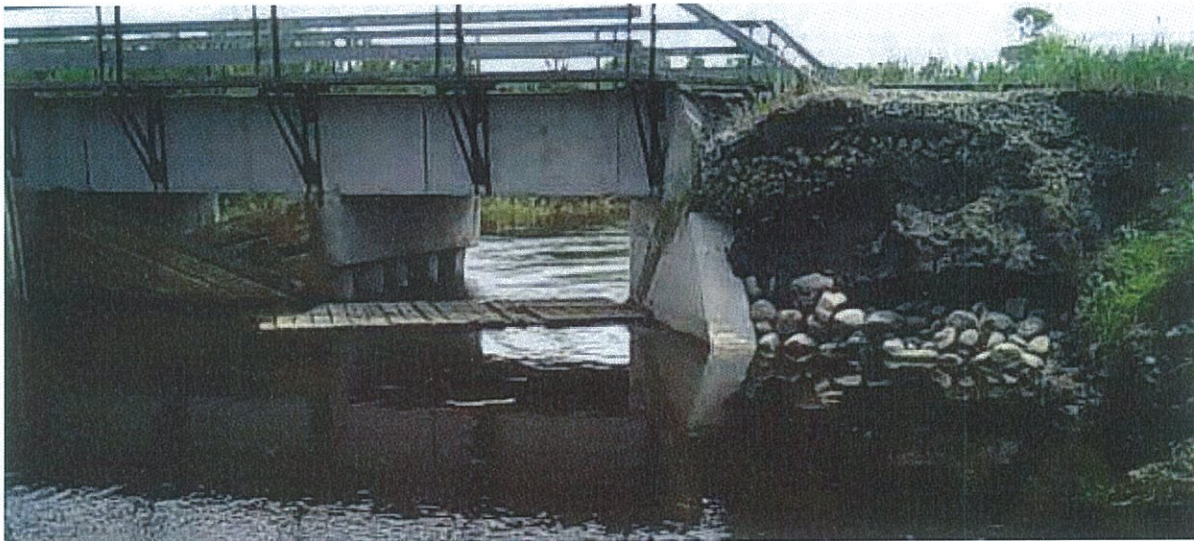
Figure 24: Damage to a Rail Bridge

In addition to the damages summarized above, the June 2014 flood also affected other agencies such as rail and oil companies (Figure 24 and Figure 25) as well as numerous private residents and farmers. Documentation of these damages is beyond the scope of this report, as efforts to quantify these damages are ongoing by other agencies such as the Provincial Disaster and Assistance Program (PDAP).

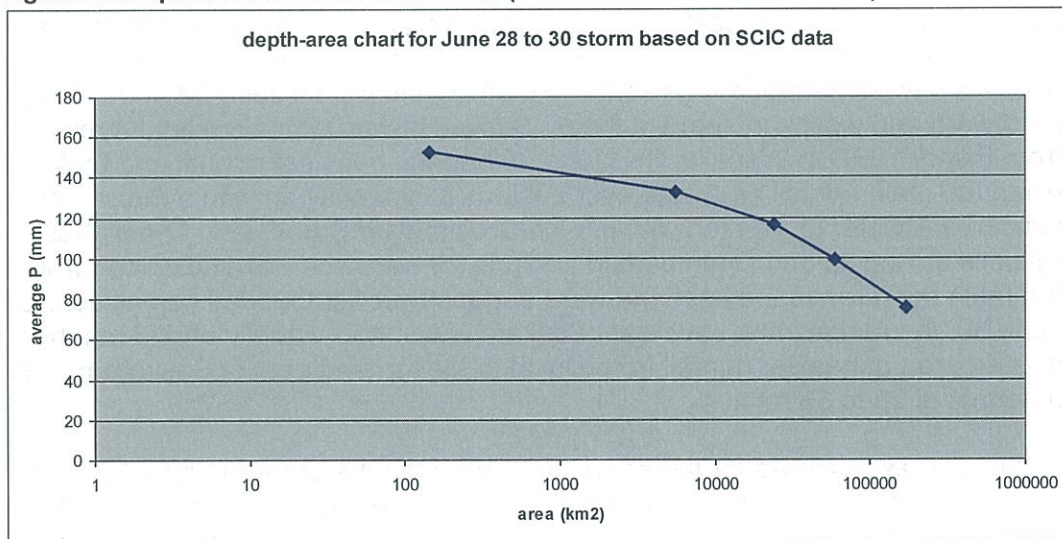
Figure 24: Depth-area chart for total storm (~ 48 hours June 28 to June 30)

Using ArcView, a depth-area curve was developed for the total storm June 28 to 30 (Figure 24). The actual duration of the storm was approximately 48 hours,

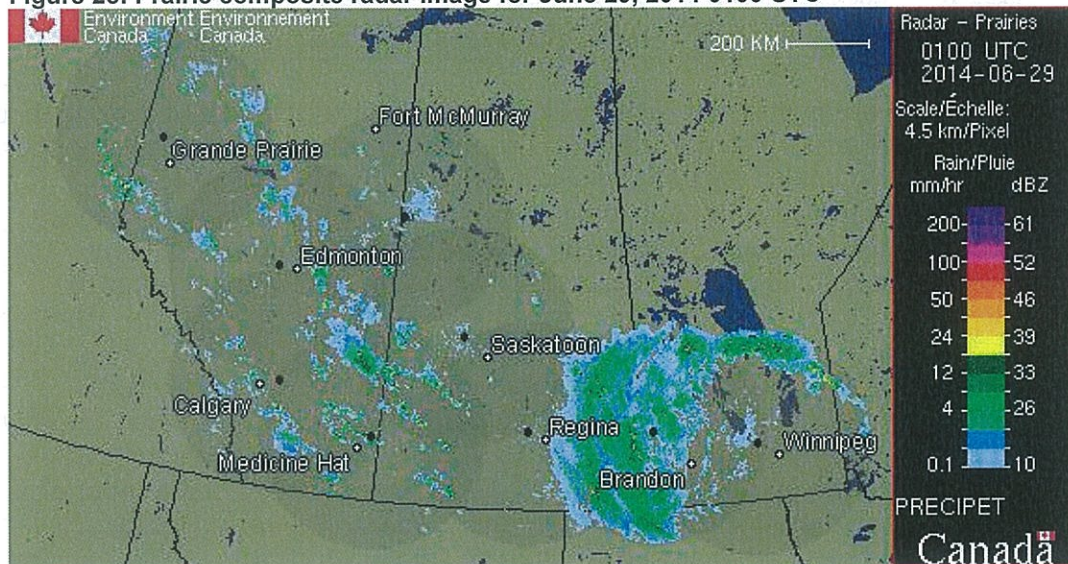
Figure 25: Prairie composite radar image for June 29, 2014 0100 UTC

The Bethune and Foxwarren radars were both operational through the storm and provided good spatial and temporal records of the storm rainfall. Figure 25 was taken from the historic radar image site maintained by Environment Canada.
